| reStore | Remove &amp; Reclad |

## Lido Beach Towers

### The Pink Lady Gets an “Energizing” Facelift

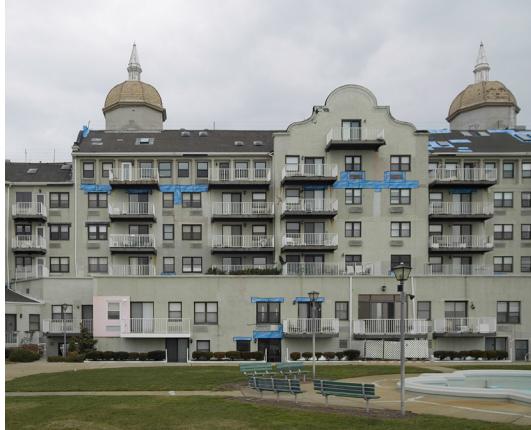
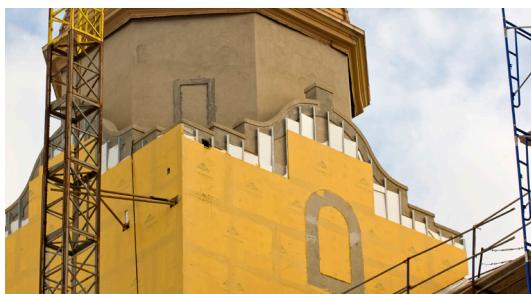
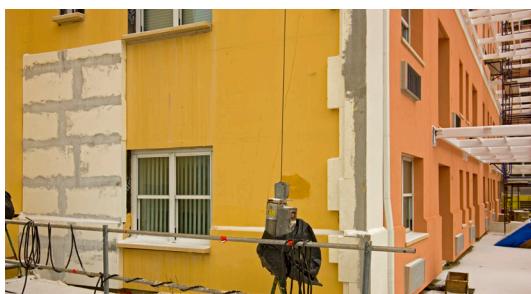
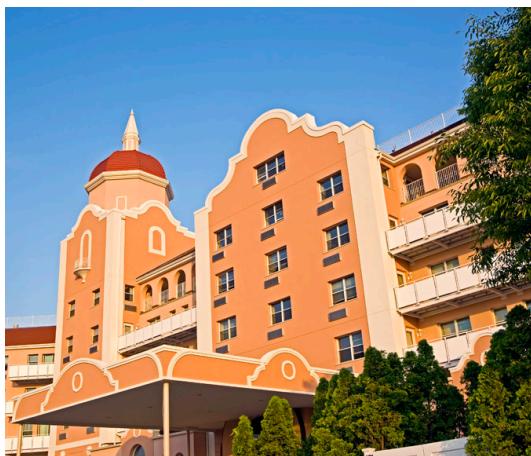
Soon, the pink was gone, replaced by drab coatings (applied over stucco on terracotta block walls). The building, already showing its half-century age, started on another 25-year slide. For years the condo board continued the strategy of applying various surface treatments, but after setting a budget to repair all the stucco, and promptly using it up in just one wing of the building, they quickly realized ongoing “band-aid” fixes wouldn’t work. Indeed the proposed cosmetic fixes to just the stucco would have cost nearly \$3 million. The eventual EIFS retrofit of the entire structure – giving the building a whole new “green” skin – came in at \$5 million. New balconies, doors, windows, roof and replacement of both cupolas – a given in either repair or retrofit scenarios – boosted the eventual price tag to over \$15 million.

Water leaks were endemic – well over 100. The original heat-pump sleeves – ordinary steel – were rusted, and condensation, produced by exterior air conditioning units, had leaked into the exterior walls, wreaking havoc in the units below. Air leaks were just as pervasive.

After securing commitments from Sto – with whom Ruzz had a 15-year relationship – that his firm would receive their full engineering and logistical support, Ruzz agreed to take on the project. His recommendation? A StoTherm™ Premier NExT® EIFS, which would essentially thermally “wrap” the building in 3”-4” of insulation.

Knowing that EIFS would address the myriad hygrothermal leaks in the structure, the immediate challenge, as Ruzz recalls, was “how to best attach the EIFS since much of the existing surface of the building was cracked, disbanded and loose.” Ruzz and contractor Anthony Colao of Flag Waterproofing & Restoration (Elmont, NY) were concerned that while fasteners might hold, the material between them would loosen. And thanks to the many surface treatments applied over the years, the walls weren’t plumb and square, making it difficult to attach anything and have it come out straight.

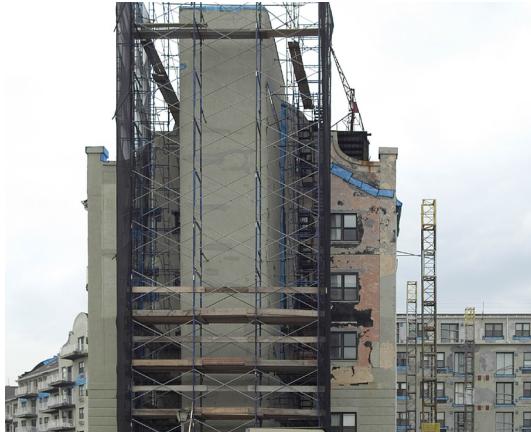
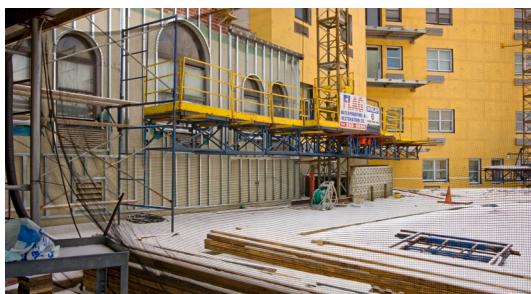
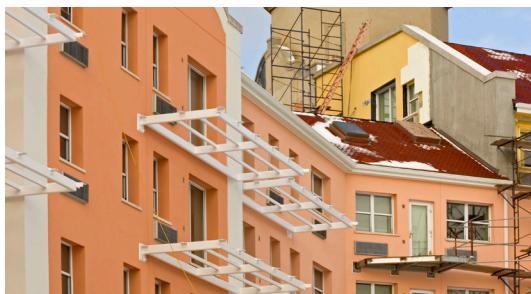
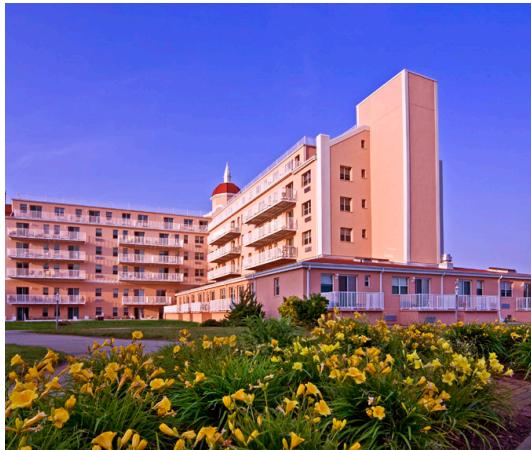
It was at this point that Ruzz and Colao devised a clever solution to address the inherent unevenness of the surface: a Z-channel arrangement composed of two attached L-angles. The angles were 10-foot sections of 18-gauge galvanized steel placed vertically on the building at 16" intervals.

Ruzz explains: "We took the first angle and conformed it to the uneven surface by cutting the perpendicular leg of the angle where necessary, so the angle bent into the unevenness." Once they had the first angle firmly affixed (using ZEMAC nail-in fasteners or screws) to the building, they attached the second angle – fabricated to be perfectly straight – to the perpendicular of the first.

The beauty of the Z-channel arrangement was that, whether or not the perpendicular portion of the first angle needed to be "cut-and-gathered" (roughly two-thirds of the building's walls required it), it offered a flat surface to which the second angle could be affixed. The other half of that second angle, a surface now parallel to the plane of the wall, offered the requisite flat and plumb surface on which to then mount the DensGlass Gold sheathing.

Sto then did a dew point analysis on the system and concluded they needed to mini-mize airflow behind the DensGlass (in the space created by the two angles), recommending two insulating strategies. First, they prescribed affixing 15 $\frac{3}{4}$ " wide pieces of 1" EPS board directly to the building wall in the 16" interval between each set of angles.

Secondly, since the walls' irregularities created varying gaps between the DensGlass and the EPS, they proposed spraying expandable foam between the two – every eight feet vertically as you moved across the wall – to fill that cavity, and ensure a firm, plumb surface on which to affix the EIFS. The DensGlass was then coated with Sto-Guard® waterproof air barrier as the final layer before the application of the EIFS.
